Office of Transport Safety Investigations

RAIL SAFETY INVESTIGATION REPORT

DERAILMENT OF PACIFIC NATIONAL SERVICE MC92

23 NOVEMBER 2011

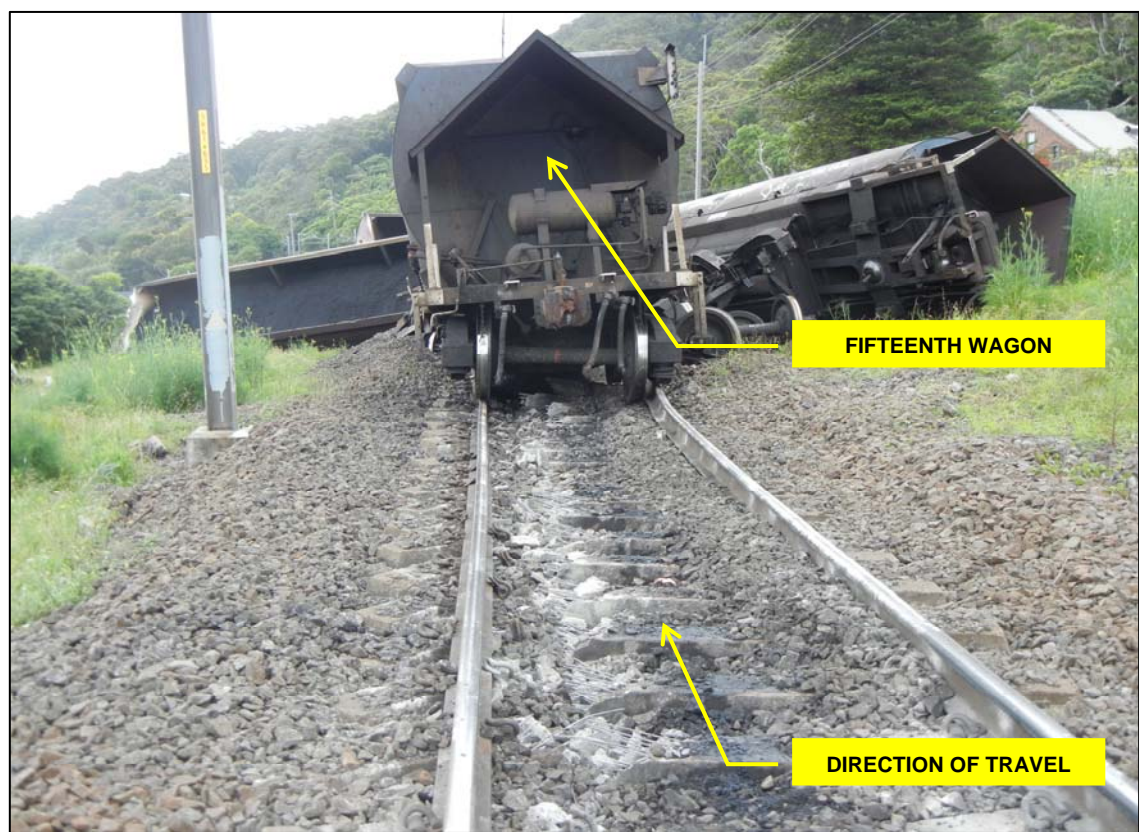
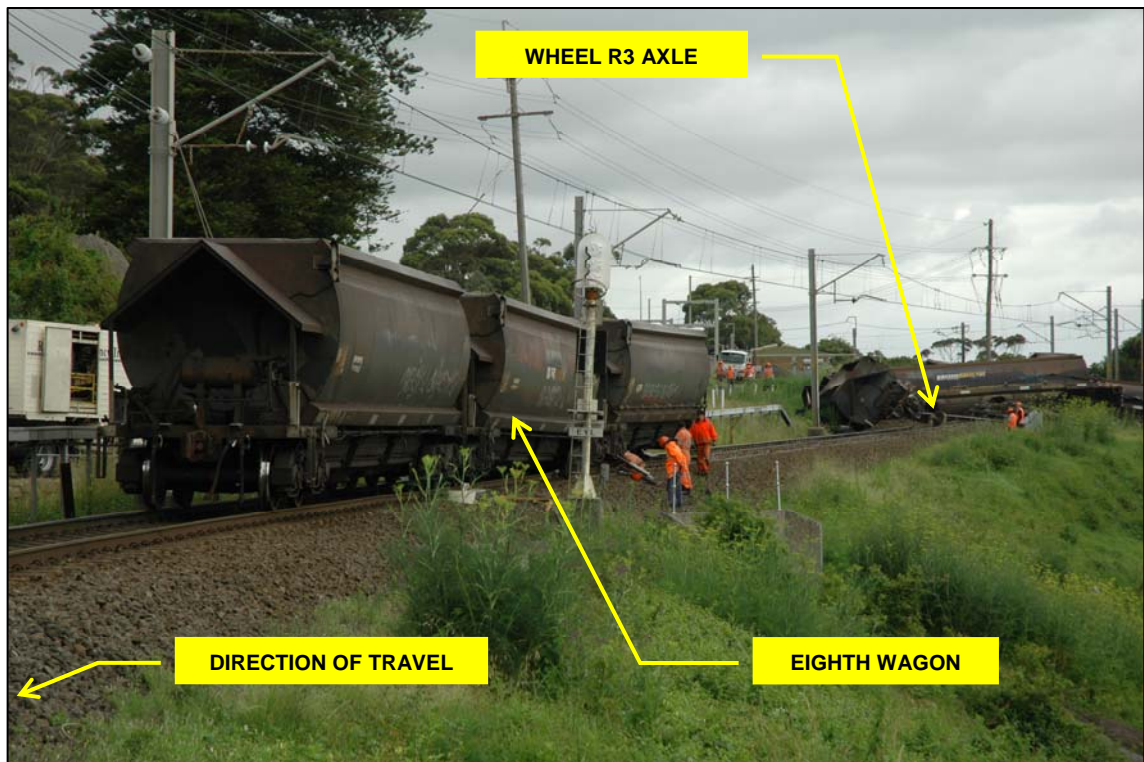
- 1.22 There were no injuries as a result of the derailment but approximately 470 metres of track and other items of infrastructure were damaged and had to be repaired. The repairs included renewal of the track between kilometrage 61.330 to 61.800, two culverts, various drainage structures and the replacement of geotechnical monitoring equipment.
- 1.23 There was no damage to the locomotives and the 37 wagons which remained on track. The other eight derailed wagons from the eighth position through to the fifteenth position sustained damage to varying degrees. The damage to derailed wagons that remained upright was minimal while those that overturned had significant structural damage (see *Photograph 3, 4 and 5*).

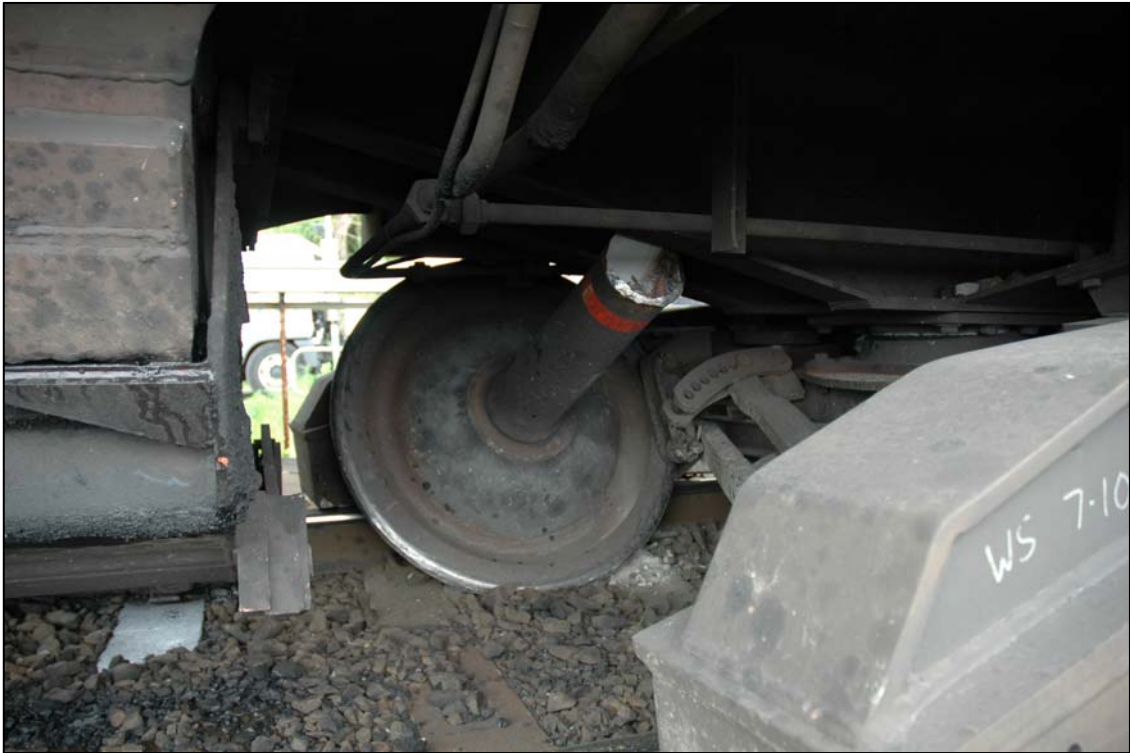
Photograph 5: Broken axle under wagon

- 1.21 A break in the No. 3 axle from the eighth position wagon was identified as an initial causal factor (see *Figure 5*). Half of the broken axle remained in-situ under the wagon with the other half found in the four foot approximately 70 metres away. As this part was exposed to the elements it was covered by plastic to protect it for later examination. A number of bogies, wheelsets and both sections of the broken axle were recovered and examined at Pacific National wagon maintenance facilities at Port Kembla. OTSI investigators witnessed the initial examination of the broken axle by a metallurgist who took samples of the axle for metallurgical examination.

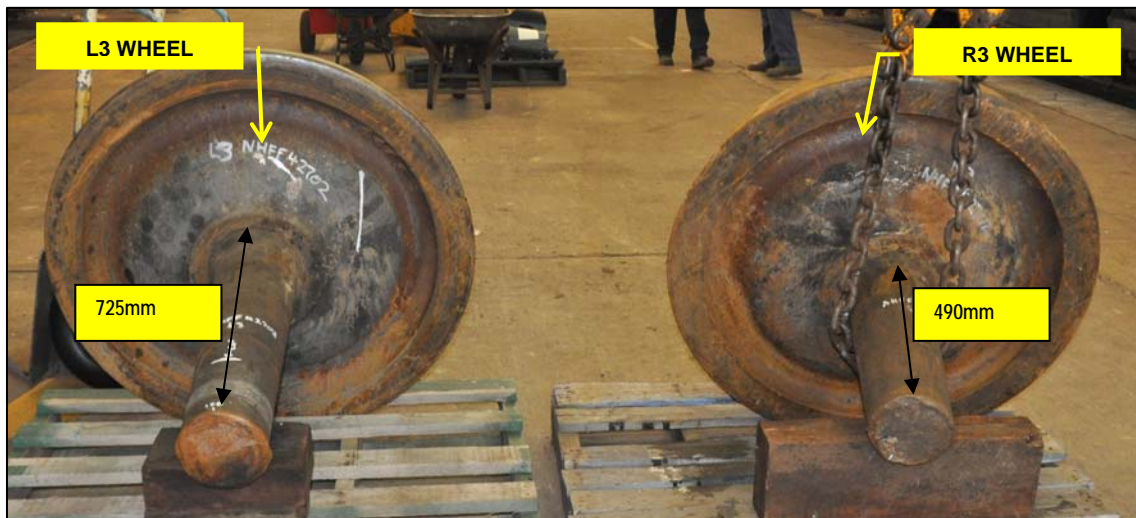
Photograph 7: L3 and R3 wheel and axle stubs

- The axle had broken approximately 490 mm from the inner wheel face of the R3 wheel and approximately 725 mm from the L3 wheel (see *Photograph 7*).

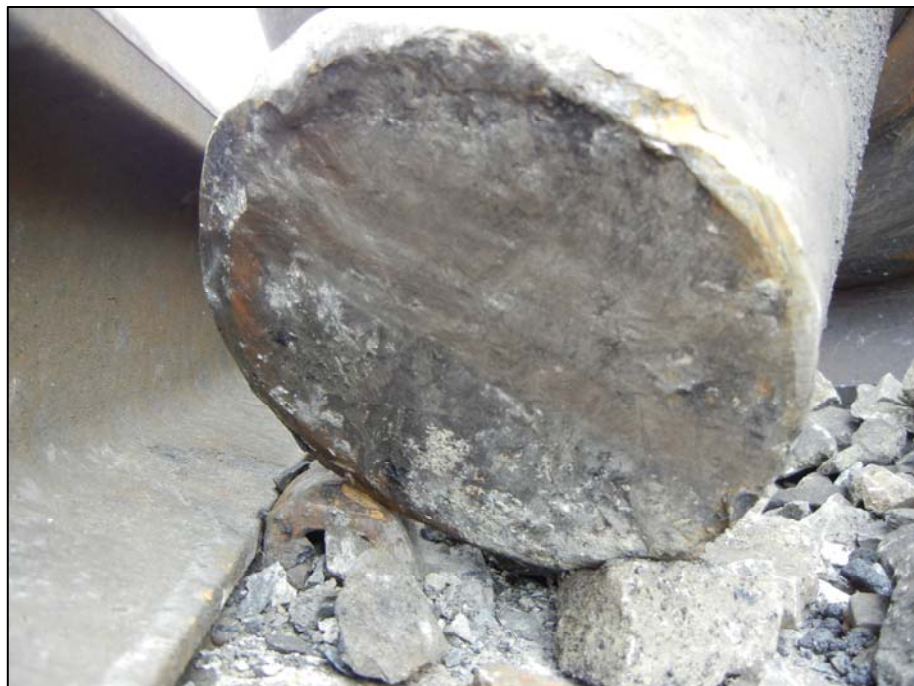
Photograph 8: Close-up of broken axle on R3 wheel end found in the four foot

- The break face on the R3 wheel side had severe damage from being tumbled under the train (see *Photograph 8*).

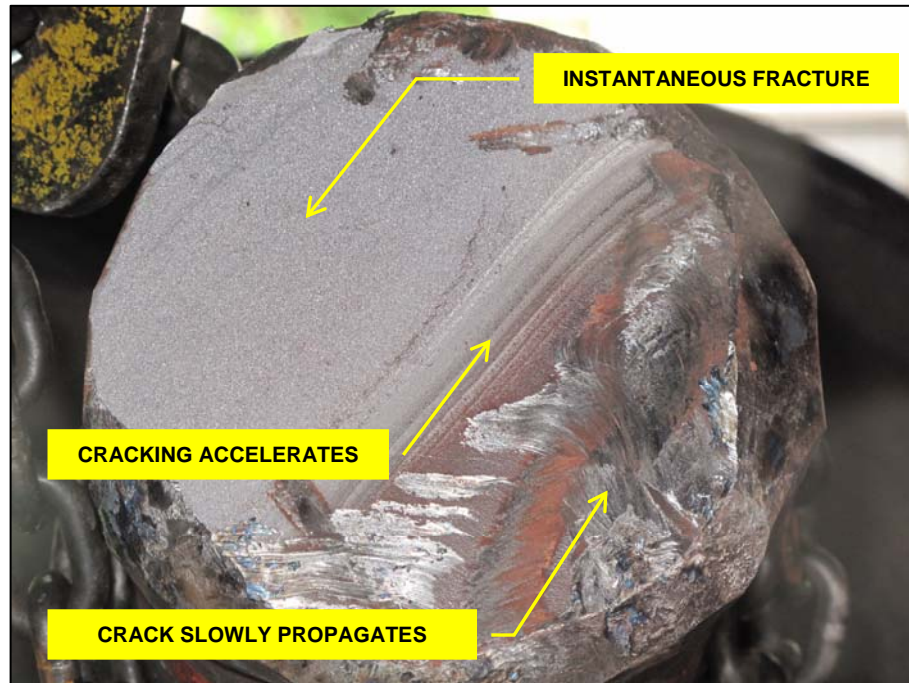
Photograph 9: Close-up of broken axle on L3 wheel end still in wagon

- The L3 wheel had some damage to the surface face with the circumference edges substantially bevelled by heavy rotational contact with the underside of the wagon during the derailment. The breakage

surface exhibited a multiple stage failure with varying rates of cracking as evidenced by ratcheting and beach marks. These marks were clearly evident in the secondary zone of failure where the cracking was seen to accelerate (see *Photograph 9*).

- There was no evidence of any abnormal condition which had initiated the fatigue cracking. The fracture initiation site was not visible due to severe mechanical damage.
- The fatigue crack had propagated slowly through approximately 45% of the cross section then accelerated through a further 8% of the cross section before final instantaneous fracture (see *Photograph 9*).

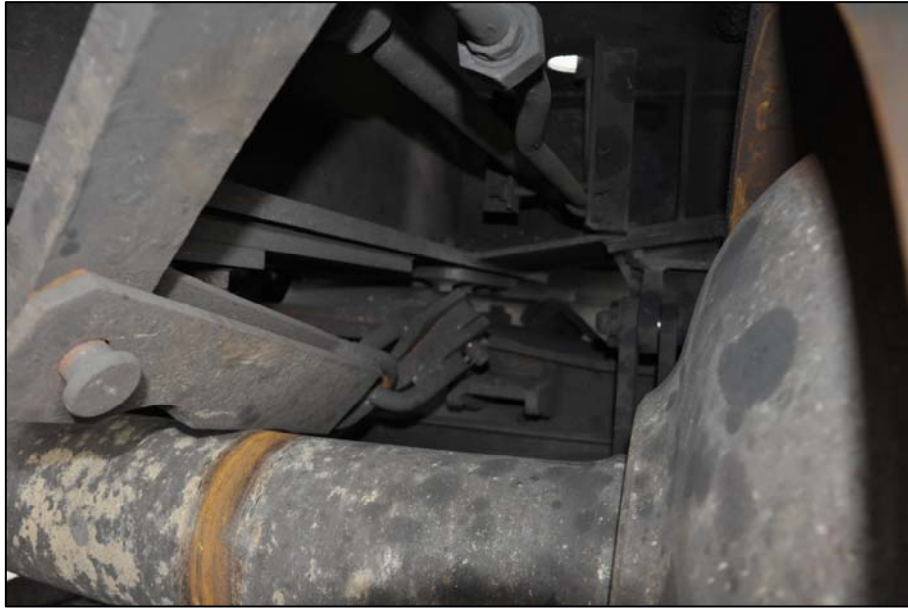
Photograph 10: Axle marking from brake gear (No.1 axle from wagon 42824F)

- The No. 4 axle, the one adjacent to the broken axle, which was the trailing wheelset of the pair, showed no marking or damage. The other axles on the wagon also showed no sign of marking or damage. (It should be noted that as these inspections were conducted at the derailment site, the parts examined had not been cleaned or wire brushed beforehand).
- Other wagons and axles on MC92 were examined immediately following the accident at Clifton and later at Port Kembla. Minor surface defects were observed on two other axles (see *Photographs 10 & 11*). Both occurred in a region of the axle where it was apparent that brake gear had rubbed on the barrel of the axle. However, these defects were within limits set in Pacific National's Wagon Maintenance

Manual. The manual specifies that remedial action is only required when specified defects exceed three millimetres in depth. It states that: *“there shall be no transverse or circumferential scoring, grooves, gouges, scratches, chisel marks or similar indentations which are more than 3 mm deep. Such defects which are less than 3 mm deep shall be handled as follows: sharp edged defects (width less than three times the depth) shall be marked for immediate workshop attention, and other defects (width more than three times the depth) may be marked for minor repair attention.”*

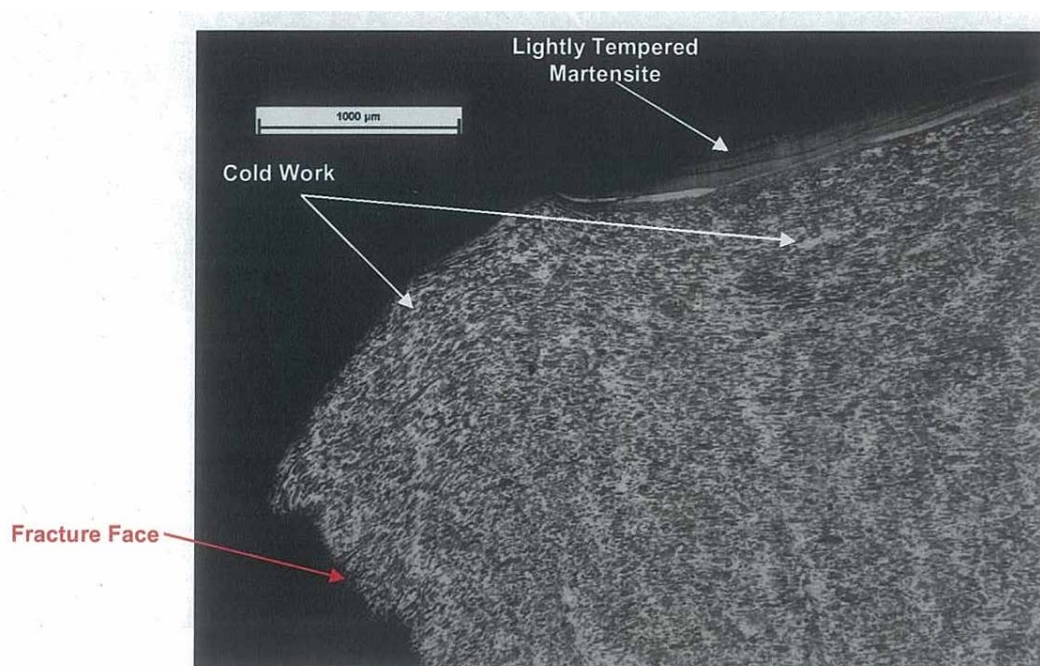
Photograph 12: Cross section at failure intersection. Magnification X25
(courtesy Bureau Veritas)

- The failure of the axle had occurred by rotational bending fatigue mechanisms in a pronounced unidirectional manner. This was indicative of conditions of low stress concentration and low nominal stress.
- There were no significant levels of non-metallic inclusions or other features in the microstructure (see *Photograph 12*). There was also no evidence of any internal flaws at or adjacent to the fracture face.

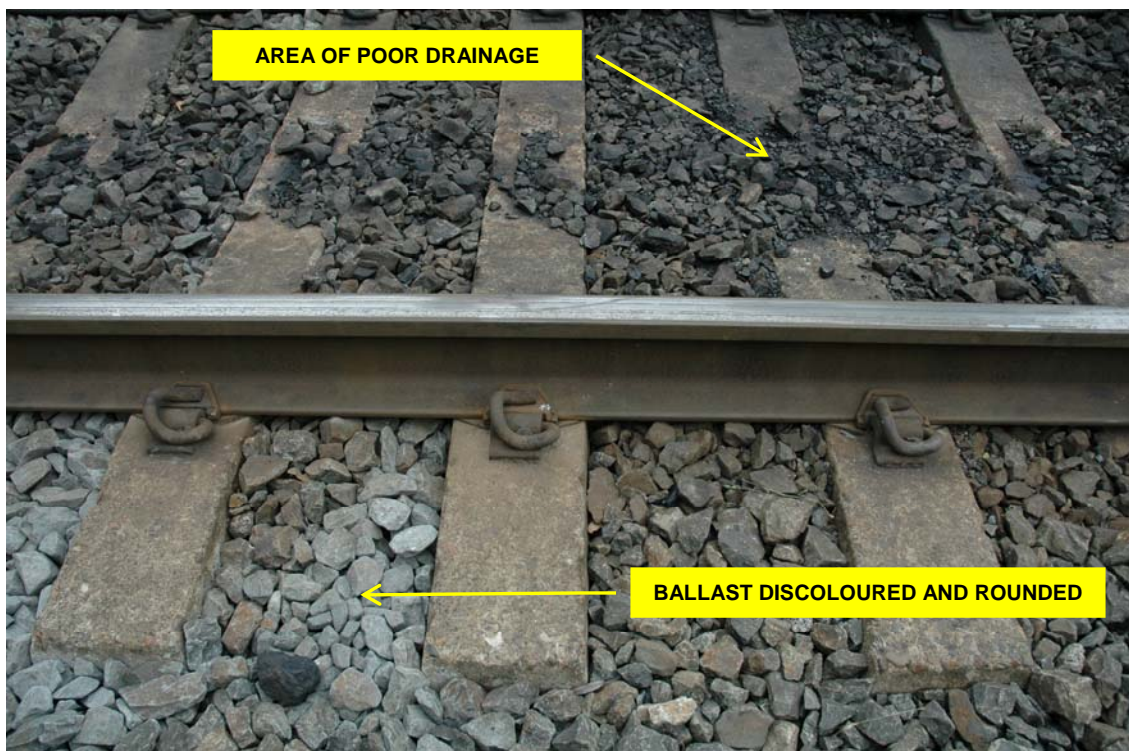
Photograph 13: Track around area of derailment

- 2.21 The area of track between where the two locomotives came to a stand was inspected following the incident. Around the area of the tunnel portal there was evidence of minor track pumping with foul and rounded ballast in the ballast crib and on the ballast shoulder (see *Photograph 13*), both in the locality of the derailment and also along the track towards the level crossing.

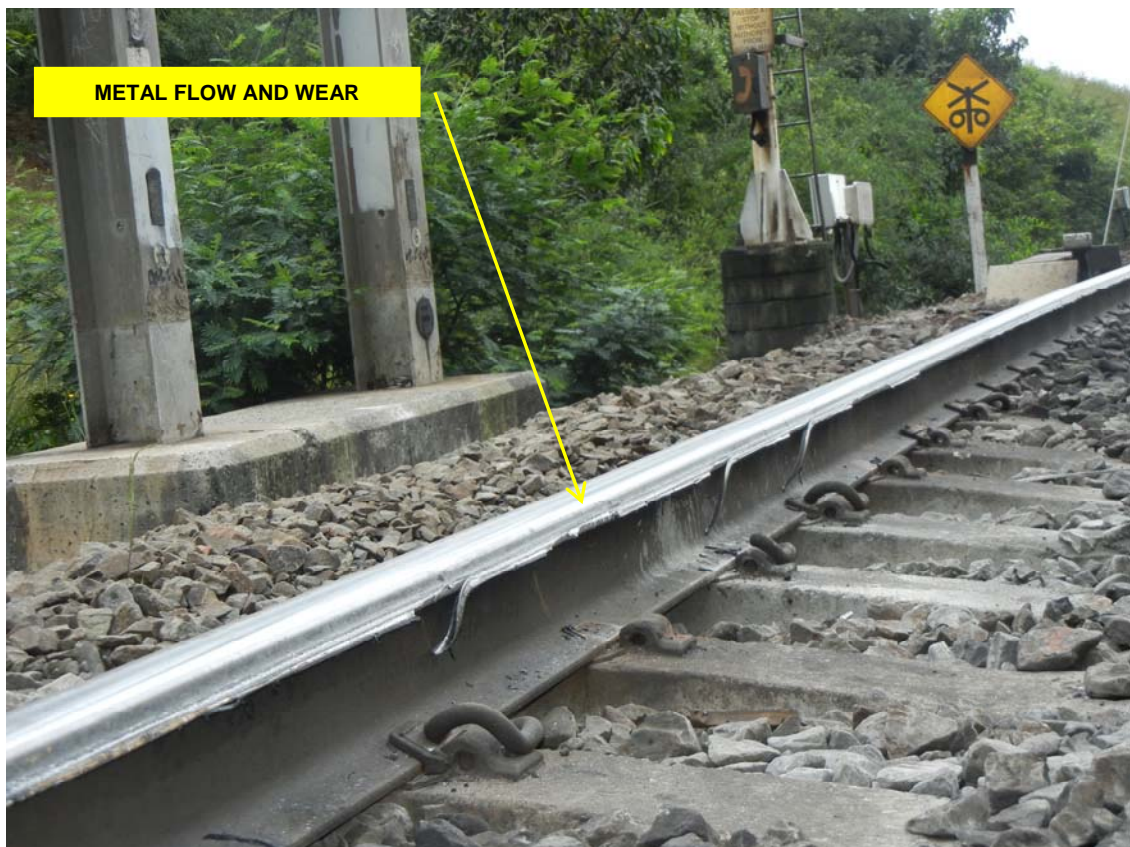
Photograph 14: Metal flow and wear on gauge face of the down rail

- 2.22 There was also significant wear and metal flow occurring on the gauge face of the rail in the locality of the derailment (see *Photograph 14*). At this point of the track there is the start of a right-hand curve where the lateral forces on the

outside rail are increased which is evidenced by the wear on the gauge face of the rail. This area of track was relatively unaffected by the derailment with some damage to the sleepers caused by the wheels from the broken axle running on the surface.
